Manhole Inspection Summary

Manhole # S250__028MH

Location Address: **1224 S.CAREY ST**

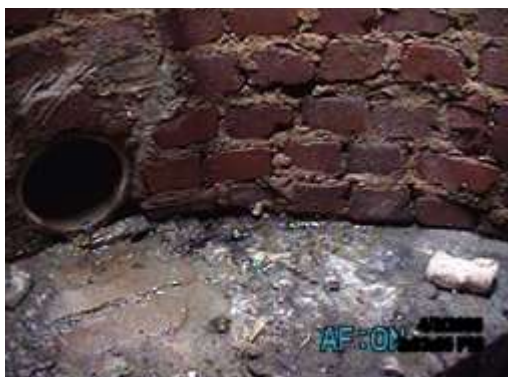
MUD SEDIMENTS

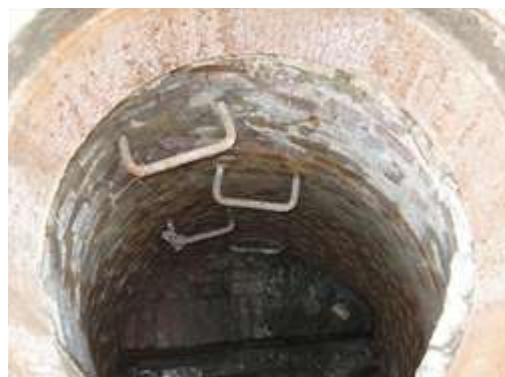
Defect 3

MUD SEDIMENTS ON BENCH

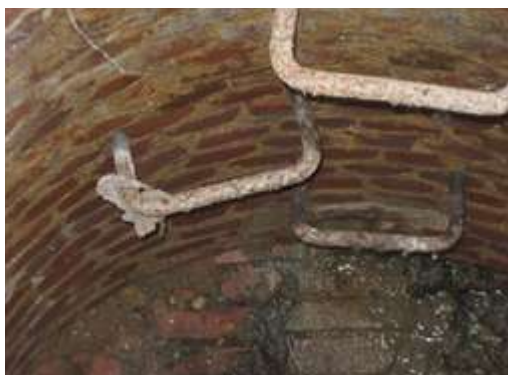
Defect 2

Condition: ☐ Sound ☒ **Cracked** ☐ Root Intrusion ☐ Loose Brick ☒ **Deteriorated**

Infiltration: ☐ None ☐ Joint ☒ **Cracks** ☒ **Mortar** ☐ Roots ☒ **Wall**

Steps Count: **4** Missing: **0** ☒ **Corroded**

CORRODED STEPS AND CHIMNEY INFILTRATION

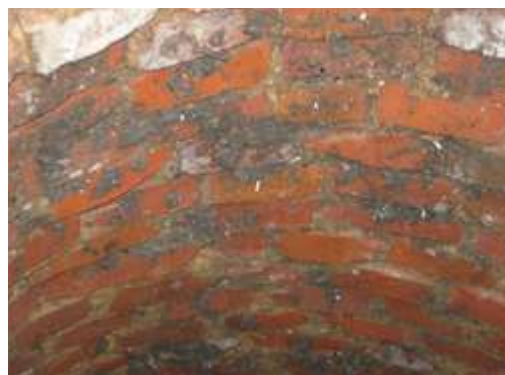
Defect 4

Surcharge ☒ **Evidence Of Surcharge** Depth: **4** (ft.) ☐ Active Surcharge Present

SURCHARGE EVIDENCE ON STEPS

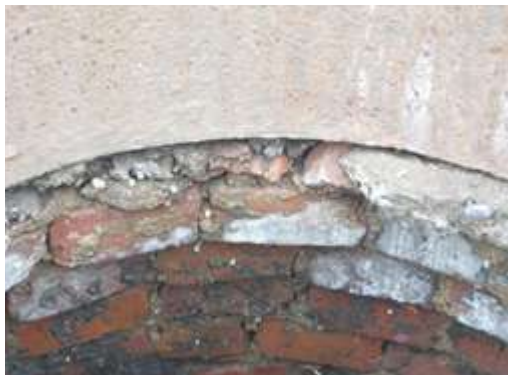
Defect 5

Condition: ☐ Sound ☒ **Cracked** ☐ Root Intrusion ☐ Loose Brick ☐ Deteriorated

Infiltration: ☐ None ☐ Joint ☒ **Cracks** ☐ Mortar ☐ Roots ☒ **Wall**

Infiltration: ☐ None ☐ Joint ☐ Cracks ☐ Mortar ☐ Roots ☒ **Wall**

CORBEL AND BARREL INFILTRATION

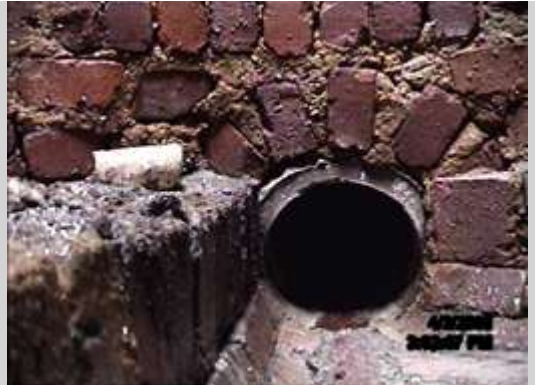
12 O'Clock Outflow

Pipe Height: **8.4** (in.) Rod and Bar (Angled)
Pipe Material: **Clay** ☐ Pipe Lined
Invert Depth: **8.19** (ft.) Flow Characteristics: **Slow**
Deposits: ☒ None ☐ Mud ☐ Sludge ☐ Debris ☐ Grease
Silt Depth: **0** (in.) Deposits Extent:
Infiltration: **Evidence** Pipe Seal Cond: **Unknown**

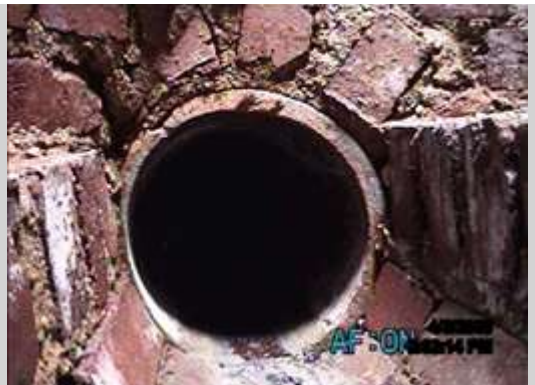
2 O'Clock Inflow

Pipe Height: **8.4** (in.) Rod and Bar (Angled)
Pipe Material: **Clay** ☐ Pipe Lined
Invert Depth: **8.00** (ft.) Flow Characteristics: **Slow**
Deposits: ☒ None ☐ Mud ☐ Sludge ☐ Debris ☐ Grease
Silt Depth: **0** (in.) Deposits Extent:
Infiltration: **Evidence** Pipe Seal Cond: **Unknown**

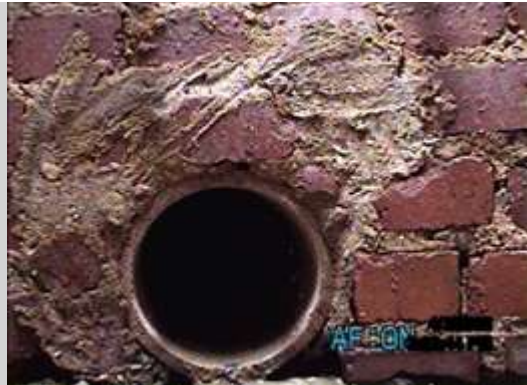
9 O'Clock Inflow

Invert Depth: **7.15** (ft.) Flow Characteristics: **Slow**

Infiltration: **Evidence** Pipe Seal Cond: **Unknown**

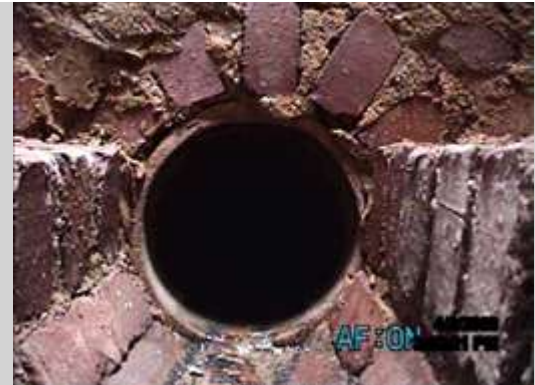
6 O'Clock Inflow

Invert Depth: **7.70** (ft.) Flow Characteristics: **None**

Infiltration: **Evidence** Pipe Seal Cond: **Unknown**

Connects To: **Dead End**
